MINE SAFETY INVESTIGATION UNIT

INFORMATION RELEASE

High potential incident

Date	18 October 2013
Event	Light vehicle crushed by D11 dozer
Location	Mount Arthur Mine, Upper Hunter Valley NSW

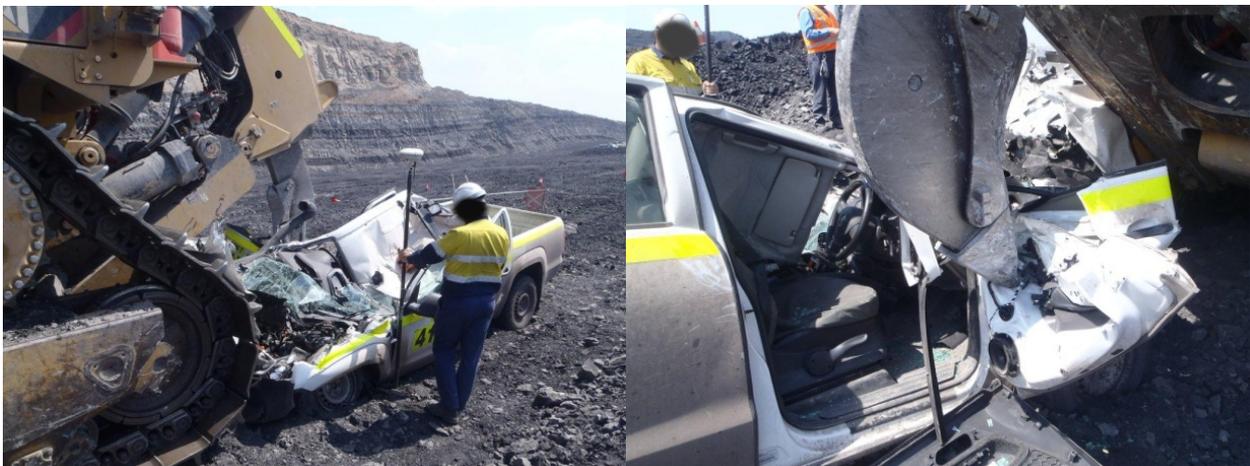
A 100 tonne D11 Caterpillar dozer (the dozer) reversed over a light vehicle (LV) that entered the work area of the dozer. The dual cabin Volkswagen Amarok utility was extensively crushed, but the LV driver was not injured.

Figure 1 Photographs of the incident scene from the passenger and driver sides, taken by the mine.

The mine's photographs are a reminder of the consequences that may occur when light vehicles come into contact with heavy earthmoving machinery. The photos also demonstrate the extent of the damage and potential for harm.

The dozer reversed 2.5 m over the passenger's side of the LV with its left hand track before stopping and moving in a forward direction. The LV driver escaped without injury.

The use of transport rules and radio communication protocols is common in many surface mine operations. These procedural controls provide soft risk management barriers and consideration should be given to more effective layers of protection to manage LV and heavy machinery interactions. These may include designated LV only roads and access areas, use of proximity detection/collision avoidance technology, or a combination of both (elimination and engineering controls).

- The effectiveness of transport management rules and procedures.
- Opportunities to eliminate LV and heavy machinery interactions.
- Implementation of hard barriers in lieu of procedural/soft controls.
- The effect and impact of human factors when reviewing risks.
- The use of technology such as collision avoidance and proximity detection systems on mining equipment and vehicles.
- The impact of task specific activities on situational awareness such as back blading.
- The adequacy of current fitness for work programs.
- The adequacy and effectiveness of radio communication systems.
